INCIDENT REPORT

Incident Type: Fire / Accidental

Investigation Title: CENTER WEIL FIRE

North Dakota State Fire Marshals Office (ND)
INCIDENT ORIGIN & CAUSE NARRATIVE
Official Law Enforcement Report – Unauthorized Dissemination is Prohibited

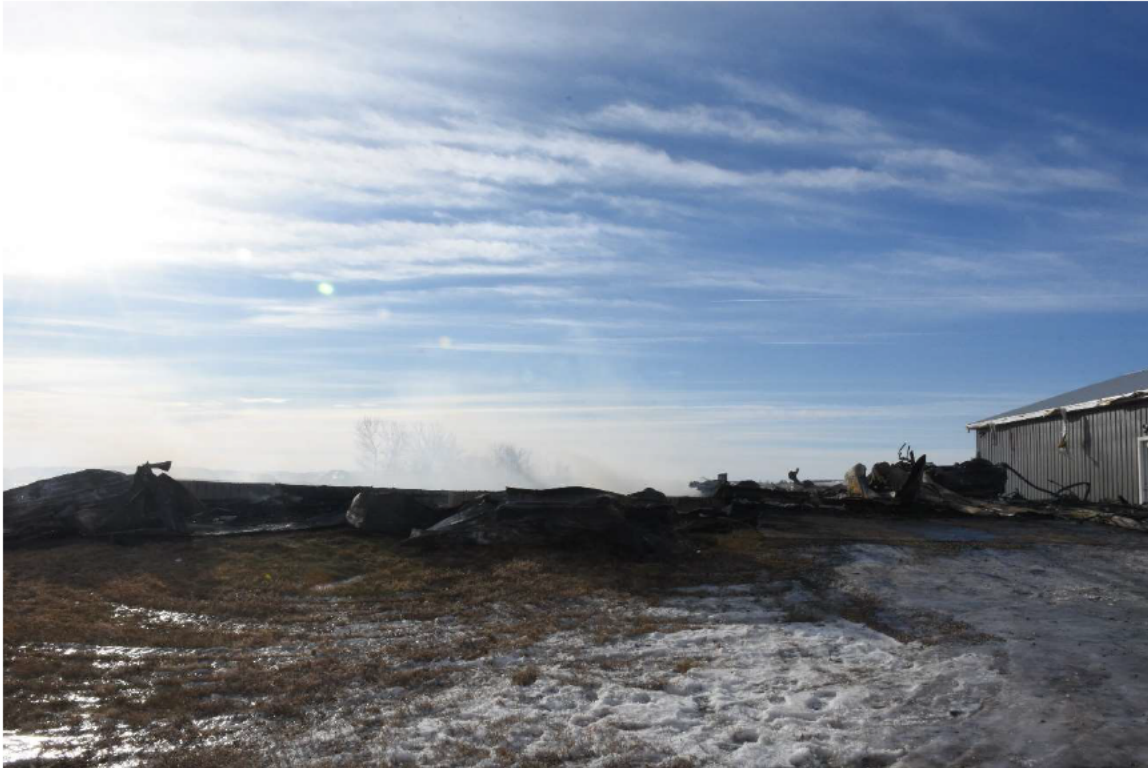
Figure 1: Photograph 2 - North Side of Structure

On January 28, 2025, a fire occurred at a residential home at 2510 30th Ave SW, Center, ND. See Figure 1.

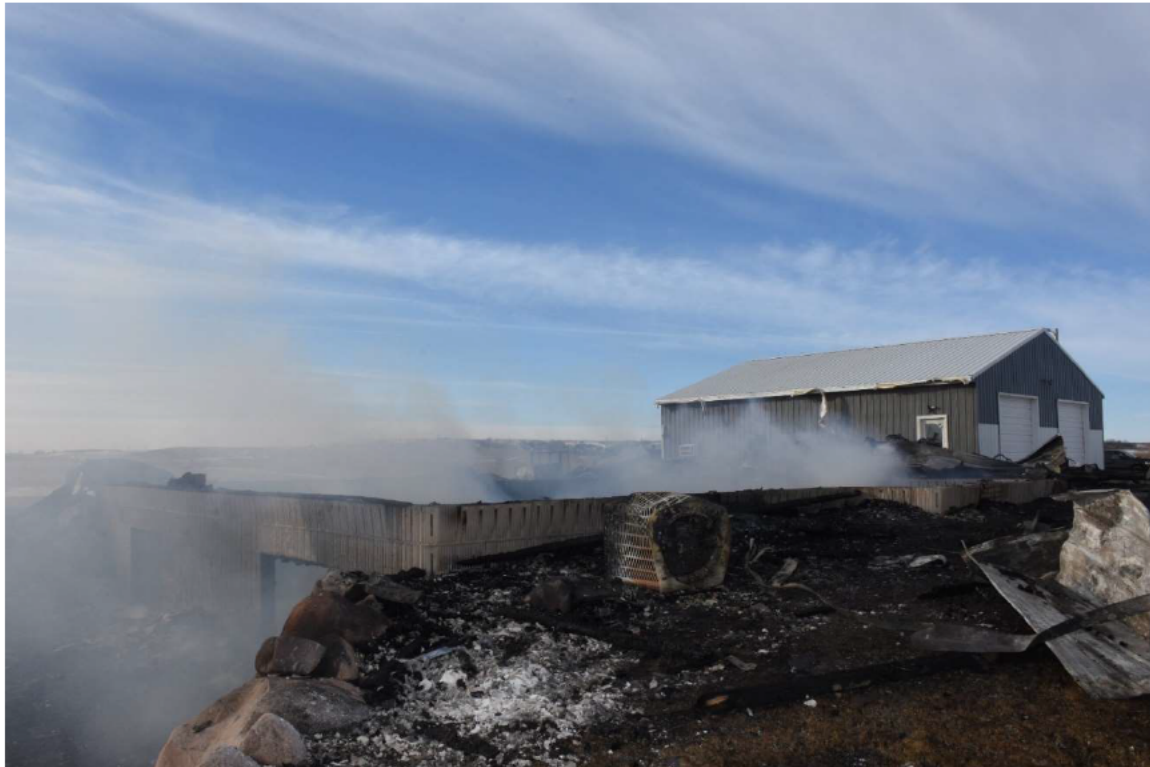
Figure 2: Photograph 14 - Northeast View of Structure, Collapsed into the Basement

The examination began with a 360° walk around that started on the north side and went in a counterclockwise direction. The structure sustained mass consumption and had collapsed to the basement. See Figure 2.

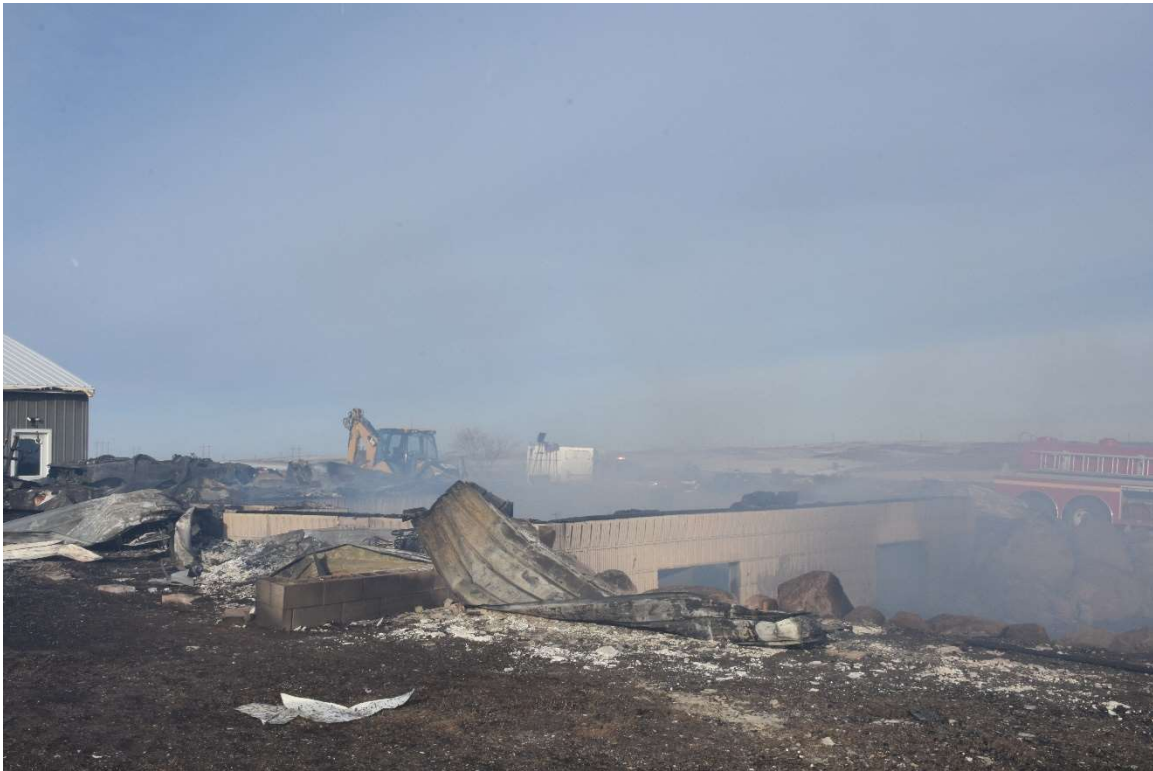
Figure 3: Photograph 11 - Southeast View; Metal Roofing Material

Metal roofing material was seen on the ground on all sides of the structure. The metal siding had sustained oxidation, heat induced color change, smoke and soot deposition, and deformation. See Figure 3.

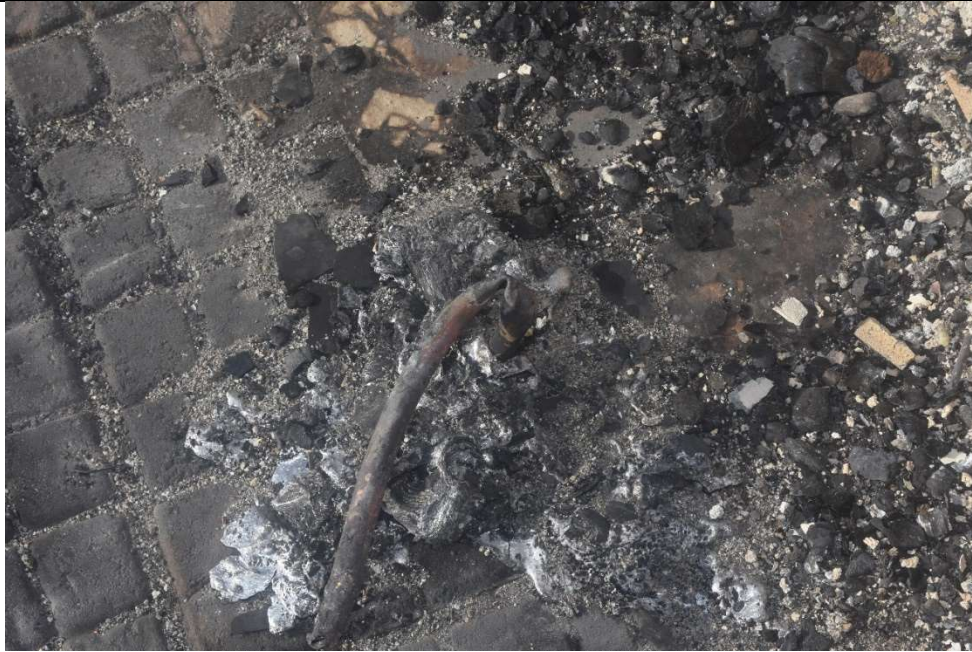
Figure 4: Photograph 107 - Metal Piping Located on South Patio

The layering process occurred to the patio area located on the south side of the structure. In the patio area, a metal table and chairs, miscellaneous artifacts, and a lawn care appliance were located in the patio area. A freezer was located in the vicinity of the patio. The table and chairs sustained oxidation, heat induced color change, and distortion. The lawn care appliance sustained mass consumption and discoloration. The freezer sustained smoke and soot discoloration and distortion. Greater amount of damage sustained to the freezer was seen top down and the sides. The east half of the patio was layered first. After layering, metal piping extending from the ground was located near the structure's south foundation wall. The piping sustained deformation and heat induced color change. The pipe was bent over towards the northwest and extended back towards the southeast along the ground. The piping was not attached to anything at the time of the examination. See Figure 4.

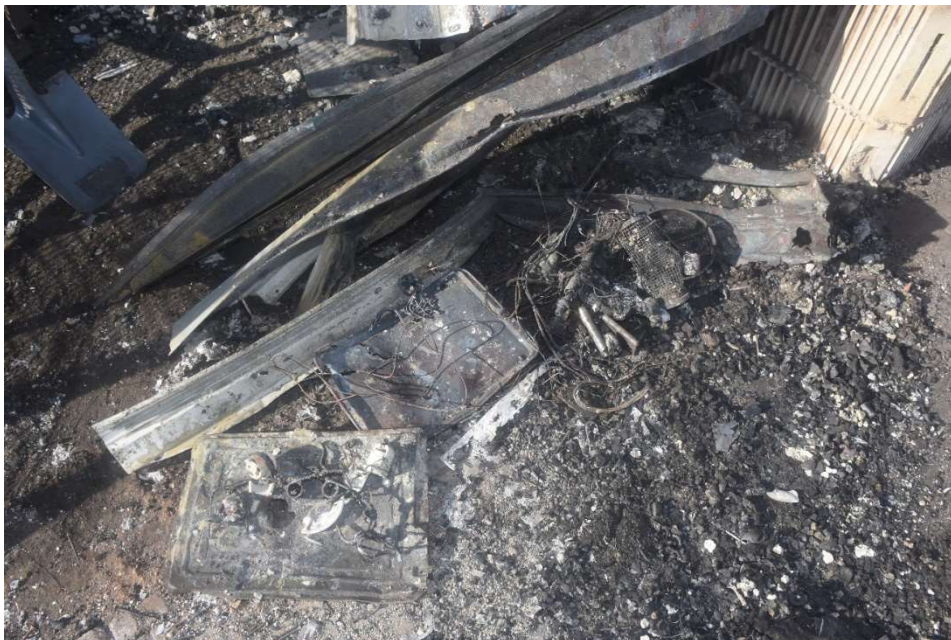
Figure 5: Photograph 110 - Items Located During Layering Process

The layering continued on the west half of the patio. Electrical wiring, a breaker panel door cover, and charred wood materials were located. Amongst the fire debris, two ceramic base sockets and two metal clamps were located. The ceramic base sockets were intact. The metal clamps sustained heat induced color change. One ceramic base socket and metal clamp were located still connected. The other components were not connected together at the time of discovery. Charred wood material and wiring were located amongst the fire debris connected together. Material fragments, similar to fabric, was located on portions of the wood material. Both sides of the wood material had similar charring and mass loss patterns. The wiring did not have any insulation. The electrical wiring located in the west half of the patio was not all intact, as multiple different wire fragments were located amongst the debris. Globules were located on various wire fragments. The electrical panel door cover located in the area sustained oxidation and heat induced color change. See Figure 5.

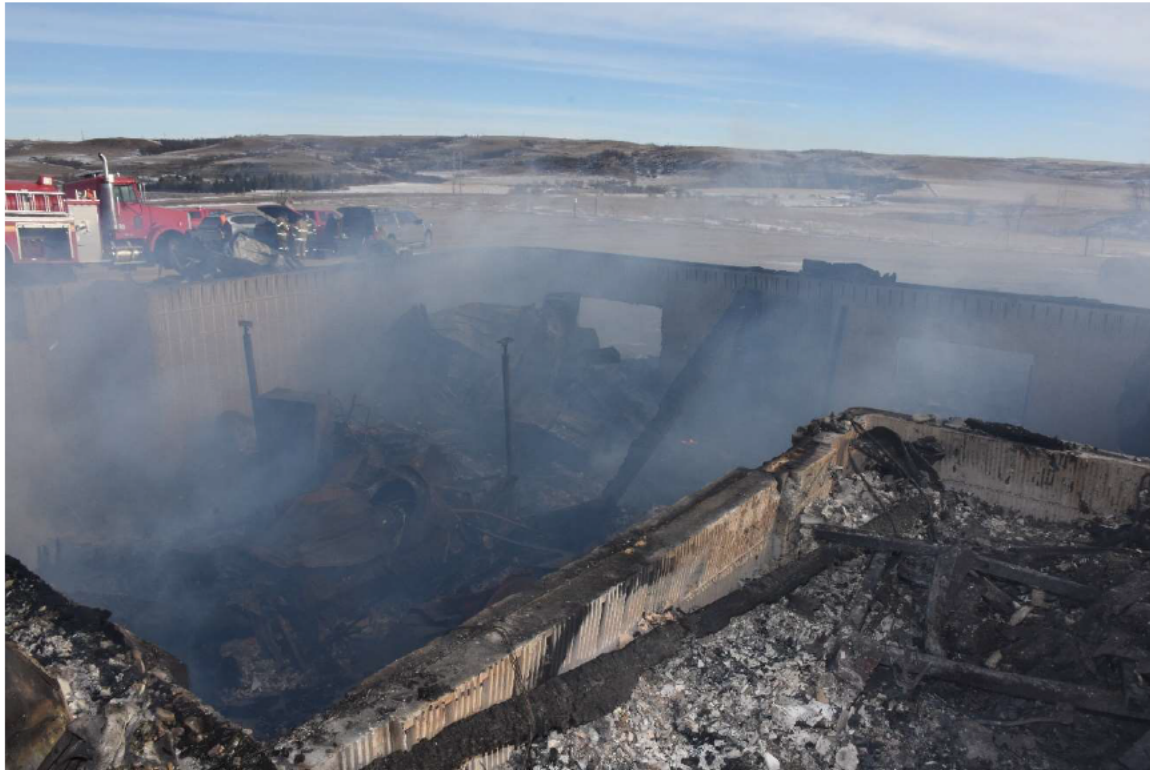
Figure 6: Photograph 18 - Southwest Interior View of Structure

Due to the extent of the damage, safety concerns and the collapse of the structure into the basement, the interior examination was limited to the areas that were cleared using heavy equipment during the search for the unaccounted-for adult victim. See Figure 6.

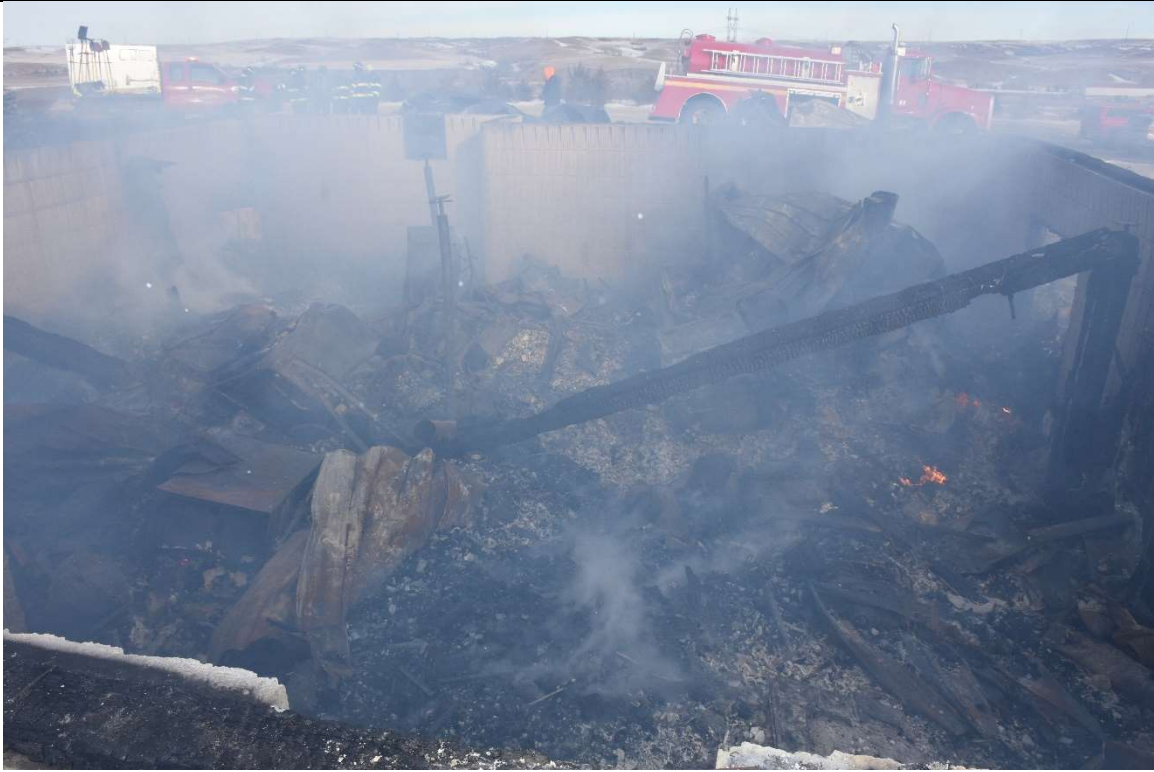
Figure 7: Photograph 19 - South View of Interior

The interior of the structure sustained full room involvement throughout all compartments. All rooms and contents reached flashover during the fire. A uniformity in the fire patterns was witnessed throughout.

The majority of combustible materials were consumed within the structure and the non-combustible materials, such as the remains of appliances were viewed throughout the interior. See Figure 7.

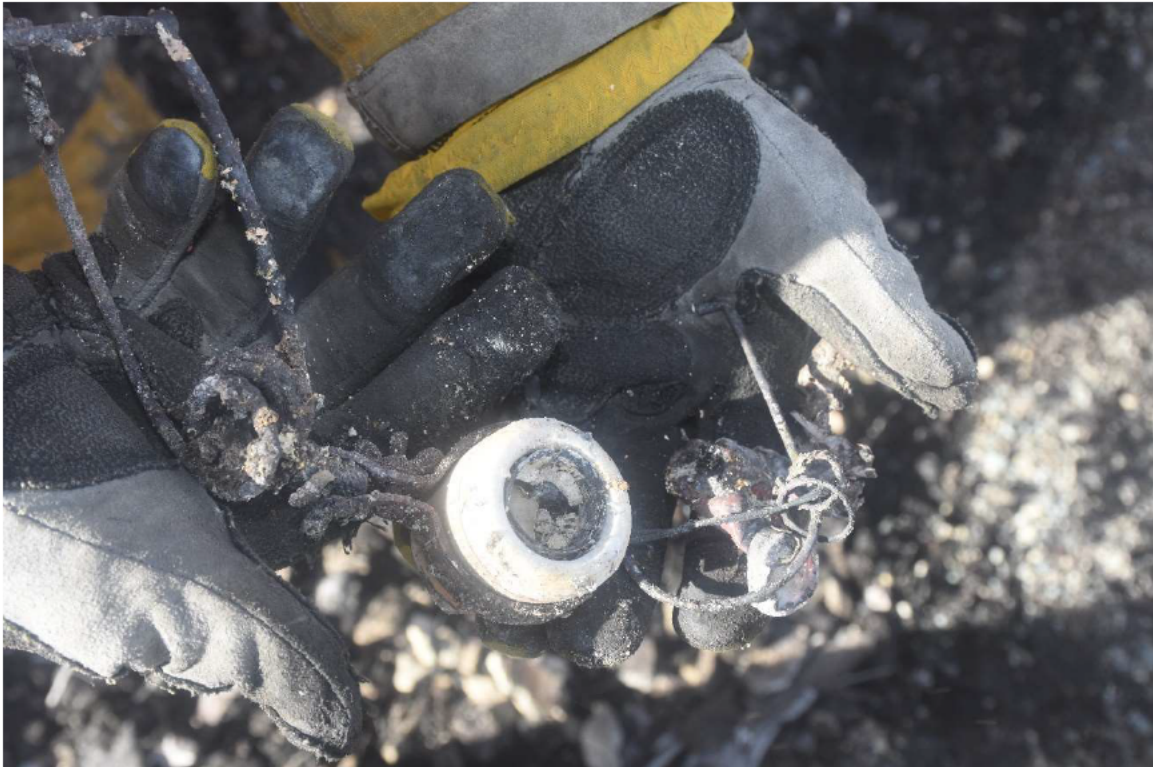
Figure 8: Photograph 98 - Connected Clamp & Ceramic Socket Housing

Heat lamp components were located in the northwest corner of the south patio. Two ceramic housings and two wire clamps. One set of metal clamps and ceramic housing were located in a separated fashion, the other clamp and ceramic housing was connected. See Figure 8.

- Physical evidentiary remains of heat lamps were located.
 - Two ceramic base sockets.
 - Two wire clamps.
 - Kirk's Section 4.4.2 "... Heat-producing electric appliances can cause ignition of susceptible fuels even when operating normally. Electric heaters ... with exposed Nichrome (resistance) heater wires offer an ignition source with surface temperatures on the order of 1150°F or greater. The hot surfaces ... can ignite most cellulose if they come into contact or near contact with them. ..."

- Charred wood and adhered fabric like material was located amongst the fire debris layered in the northwest corner with the heat lamp components.
 - Wiring fragments were observed on the charred materials.

Based upon the systematic examination of the fire scene, fire patterns, witness statements, interviews, located physical evidence, and video footage, the cause of the fire was the ignition of ordinary combustible materials such as blankets and an old heating pad by contact or radiant heat from electric heat lamps.

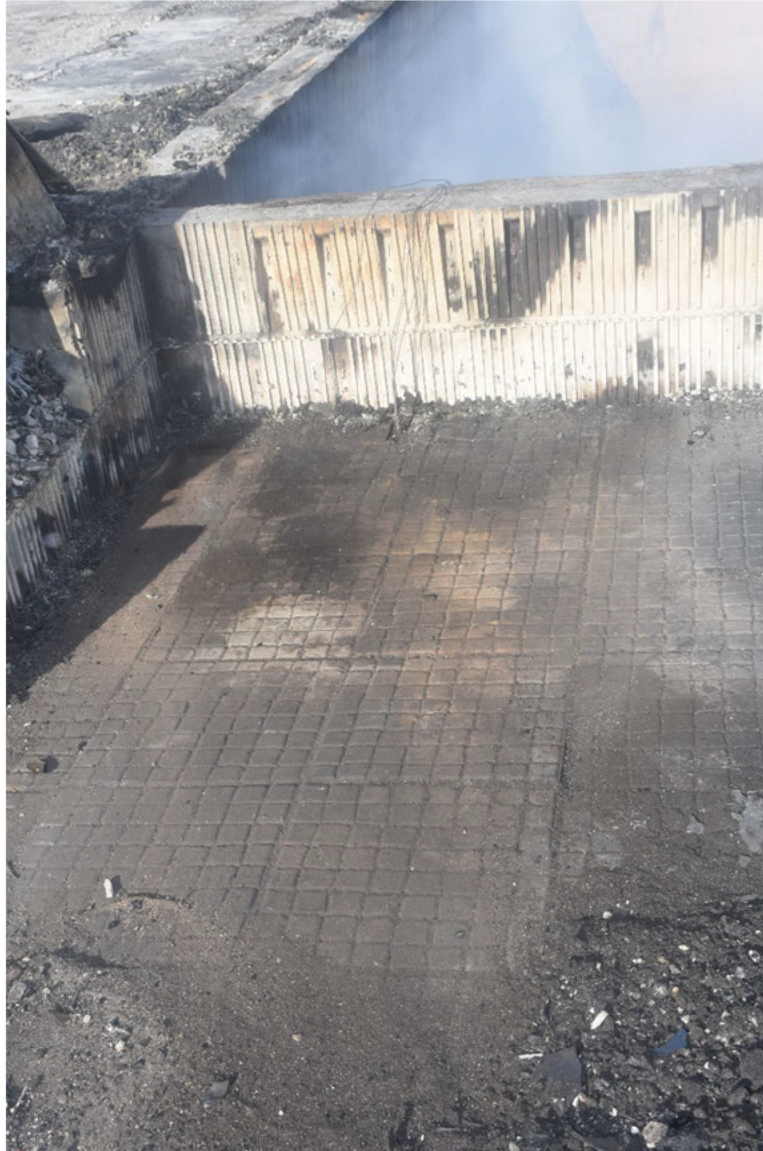
Based upon the systematic examination of the fire scene, the area of origin was determined to be in the northwest corner of the covered patio area, on the south side of the structure. The following supports this:

- Greater amount of smoke and soot staining to the patio pavers and the foundation at and around the northwest corner of the patio area compared to the northeast corner.
- Greater amount of discoloration occurred at and near where the patio pavers and foundation came into contact along the garage (west wall).

- Smoke and soot staining lessened on the patio pavers as fire extended outward and upward.
- Smoke and soot staining on the foundation was in an up and out direction away from the northwest corner area.
- Discoloration was at ground level up along the west foundation and extended upwards compared to no discoloration at the east foundation.
